NORTH OF THE WALL  
**TYNEDALE  
ARCHAEOLOGY  
GROUP**

**Greyside Farmstead  
Molehill and Test Pit Survey  
March 9<sup>th</sup> – 11<sup>th</sup> 2019**

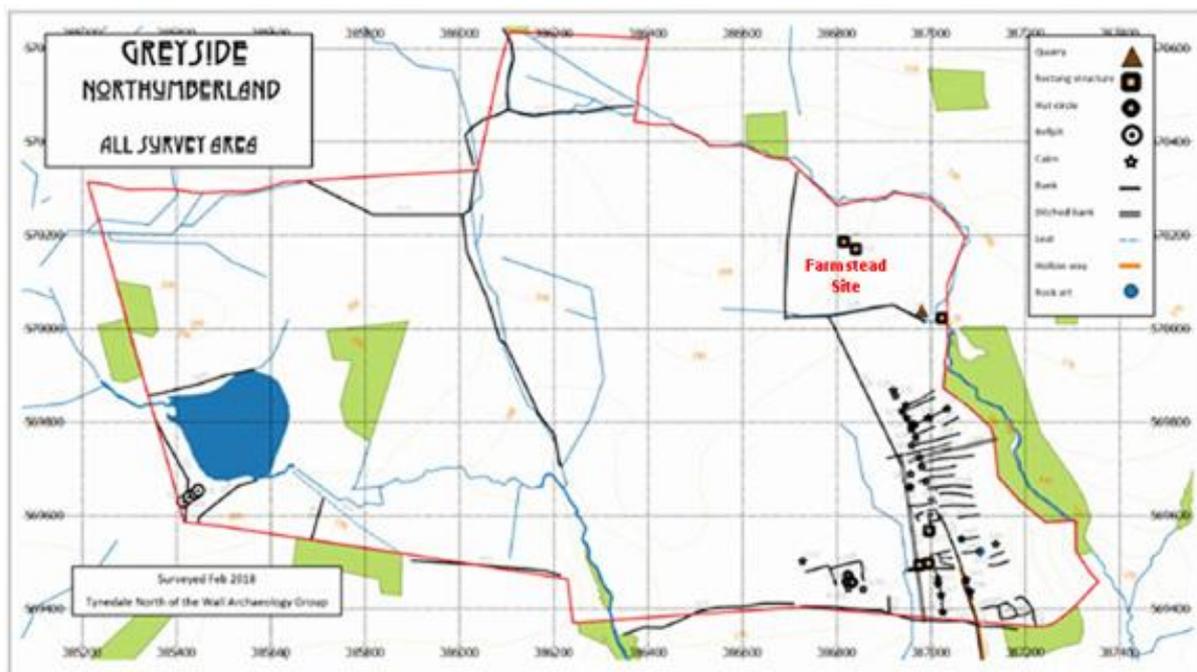
Fig 2. 2018 Greyside Survey Area ... all features

As figure 2 below illustrates, the farmstead site is located within an area bounded by the low lying remains of a north-south field boundary running from the present-day northern field boundary to a prominent bank and ditch running east-west. In turn, further low lying remains of a field boundary run south from the ditch and bank and continues to the southern boundary of the present-day field. To the east of this north-south boundary are the quite extensive remains of what appears to be a medieval field system.

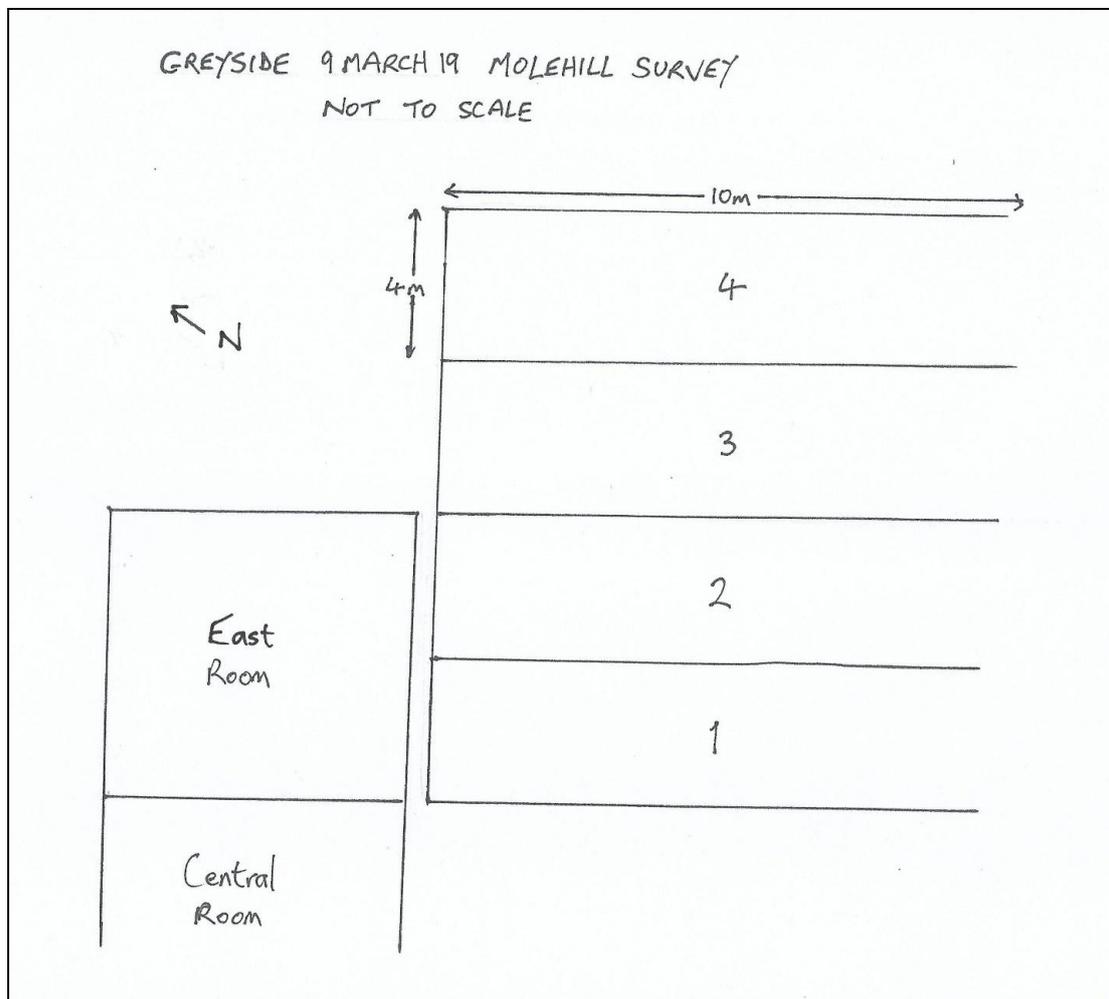
Fig. 3. Plan of molehill survey grids

It was decided to examine a 16m x 10m cluster of molehills lying to the south-east and adjacent to the rectangular outlines of a possible dwelling. Small pieces of glazed pottery could be seen in some of the molehills, which had appeared since the previous visit a year ago. There were a few other molehills lying outside the main cluster, to the north-east of the eastern room of the building, and these were also examined, the finds being categorised as outliers.

A grid was constructed over the main area of molehills, consisting of four 4m x 10m rectangles aligned with the south wall of the building. Finds from each rectangle and the outlier area were collected separately for later washing, examination and photography.

It was pleasing to see the lime mortar restricted to the grids nearest the house wall, indicating that organised molehill collections can give an indication of distribution of finds. The use of mortar again suggests a relatively recent date in such a remote location where the older, similar types of building such as shielings would have been drystone.

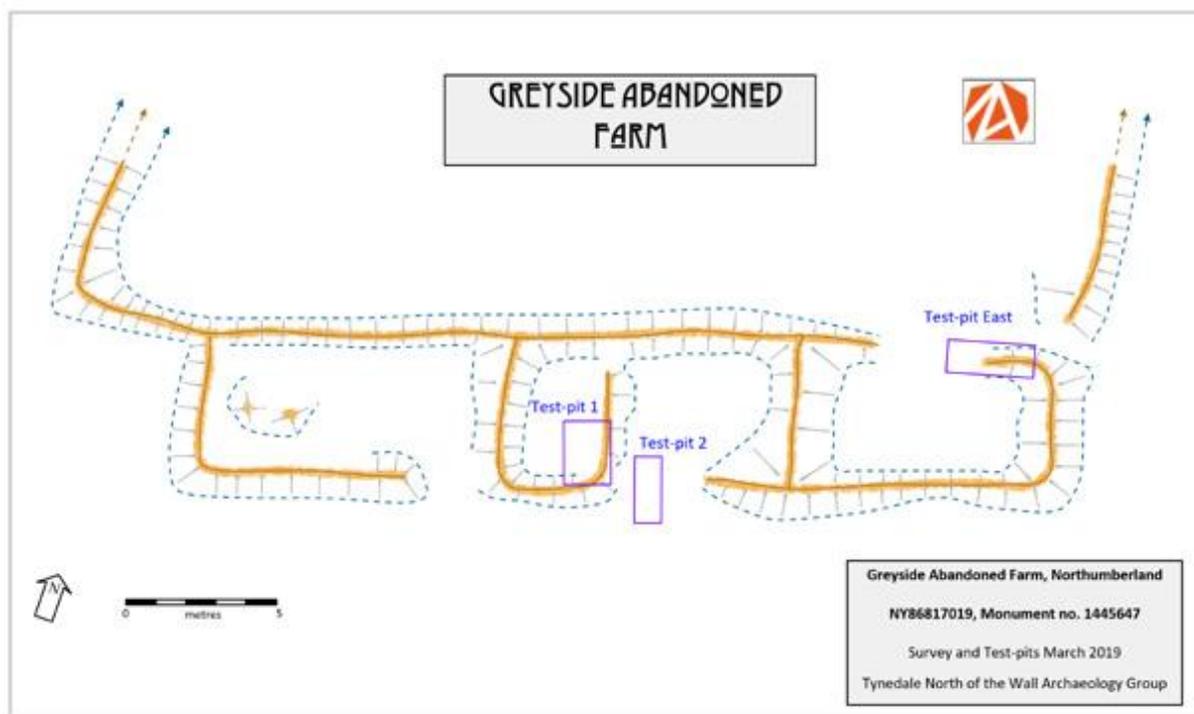
**Fig. 4. Plan of farmstead building with test-pit locations**

Three target areas were selected, as illustrated on figure 4 below:

1. Test-pit 1 ... in the central cell of the building in order to investigate what appeared to be a partition wall dividing the cell.
2. Test-pit 2 ... across the presumed entrance into the central cell.
3. Test-pit East ... on the northern side of the eastern cell where an entrance appeared to open onto the D-shaped enclosure, thought to be a livestock enclosure.

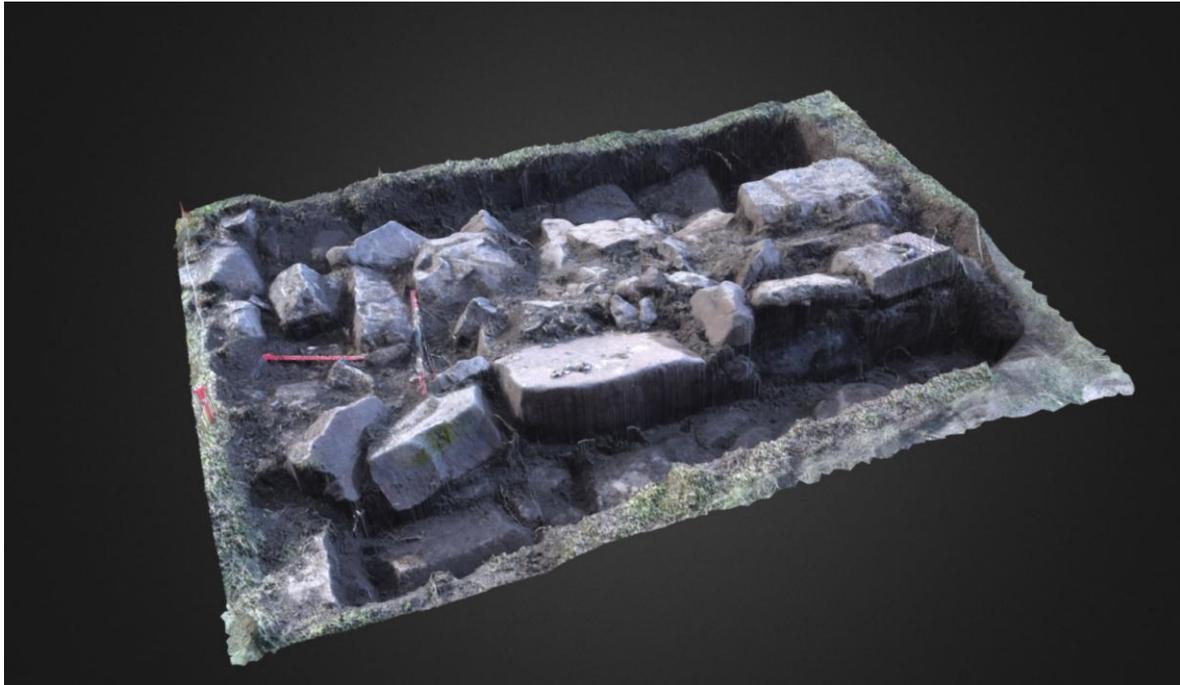
**Fig. 5. Photogrammetric image of Test-pit 1 (Red peg indicates north. Scale rod = 50cm )**

Upon excavation it became apparent that what we had thought might be a partition wall was a more substantial stone-built structure, double-faced and 1m wide. Although initially planned as a 2m x 1m test-pit, we extended it to 2.5m x 1.75m in the light of the substantial nature of the N-S wall being uncovered. As a result of this extension we were able to identify that to both the west and the east of the wall the floor surface was stone covered.

Among a limited amount of small finds was a piece of broken slate suggesting that at its final phase of occupation the building was, at least in part, slate-roofed. In the time available it was not possible to extend the test-pit further north in order to identify a possible entrance.

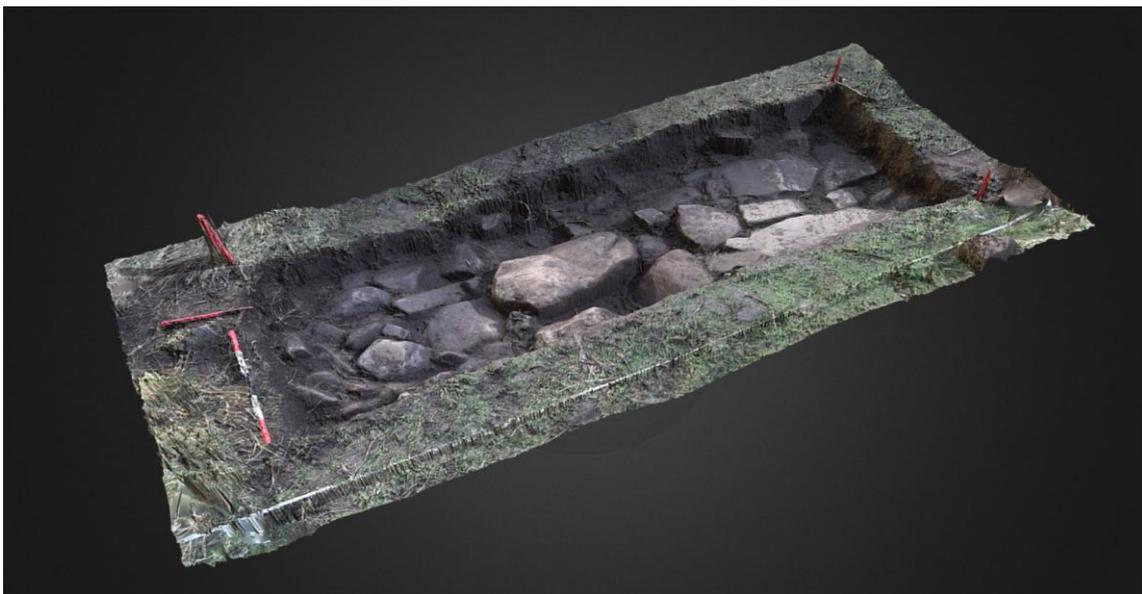
**Fig. 6. Photogrammetric image of Test-pit 2.**

Test-pit 2 was planned as 2m x 1m N-S across the probable entrance into the central cell of the building and extending south beyond the E-W line of the southern wall. When we discovered that the stone-covered surface continued south beyond the external wall, we extended a further 1m. As the stone-covered surface had not terminated within the extended area it appears likely that there would have been a stone path leading to the probable entrance.

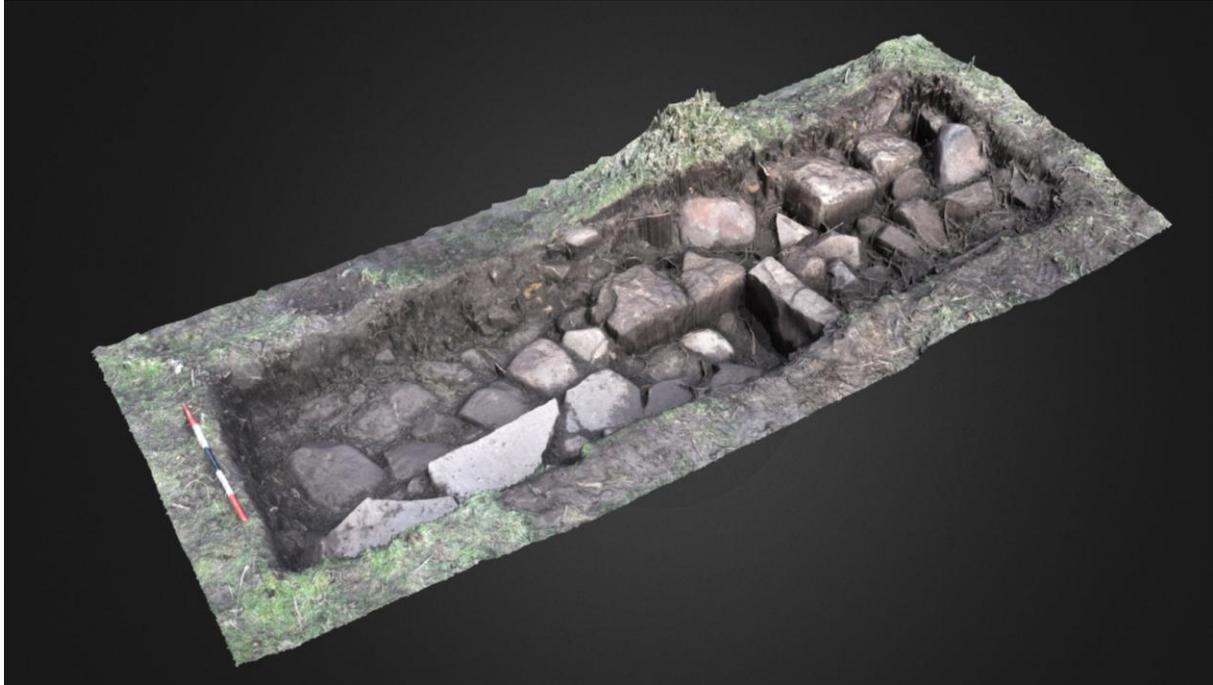
**Fig. 7. Photogrammetric image of eastern test-pit**

A 3m x 1m E-W test-pit was excavated with the objective of finding evidence of a north facing entrance to what might have been a byre or barn related to the large enclosure.

Although this exploratory test-pit does not fully resolve the identification of the entrance, or the function of the building, the surface immediately west of the possible terminus of the wall (indicated by the upright stone slab just to the right of the centre of the southern edge of the test-pit) is stone-covered and includes pieces of broken flagstone.

There was insufficient time to extend further south to identify whether this stone surface continues within the eastern cell of the building.

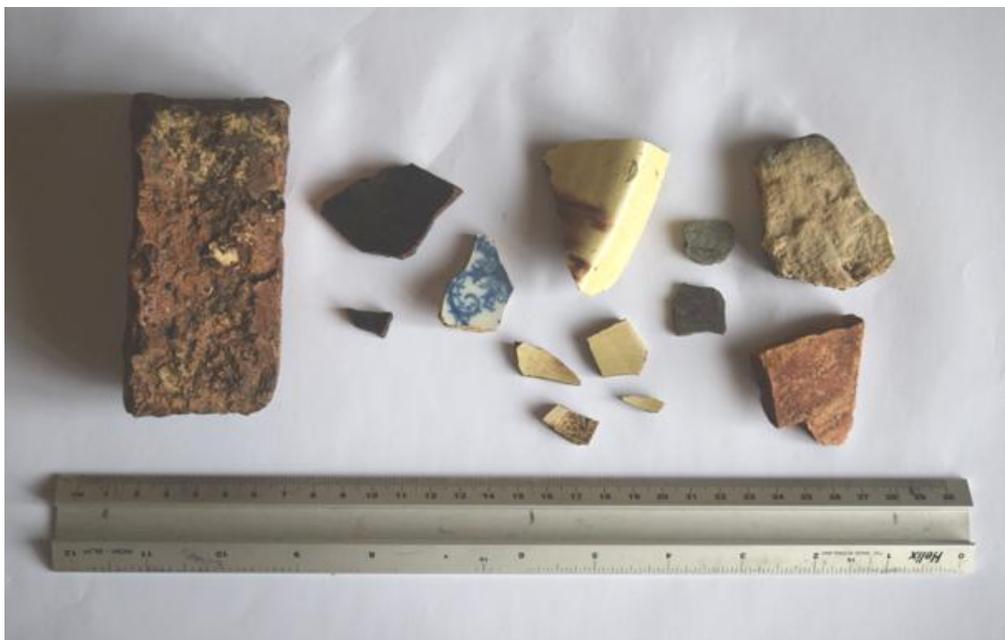
**Fig. 8. Finds from eastern test-pit**

Finds included two pieces of coarse brick, two small fragments of slate, pieces of glazed ware and a sherd of a decoratively glazed terracotta lipped bowl as shown in figure 8 below.
